Crystal River Nuclear Plant  
Docket No. 50-302  
Operating License No. DPR-72

October 29, 2004  
3F1004-06

Subject: LICENSEE EVENT REPORT 50-302/2004-003-00

4. TITLE Reactor Trip And Emergency Feedwater Actuation Caused By 230 Kilovolt Switchyard/Transmission Faults
--

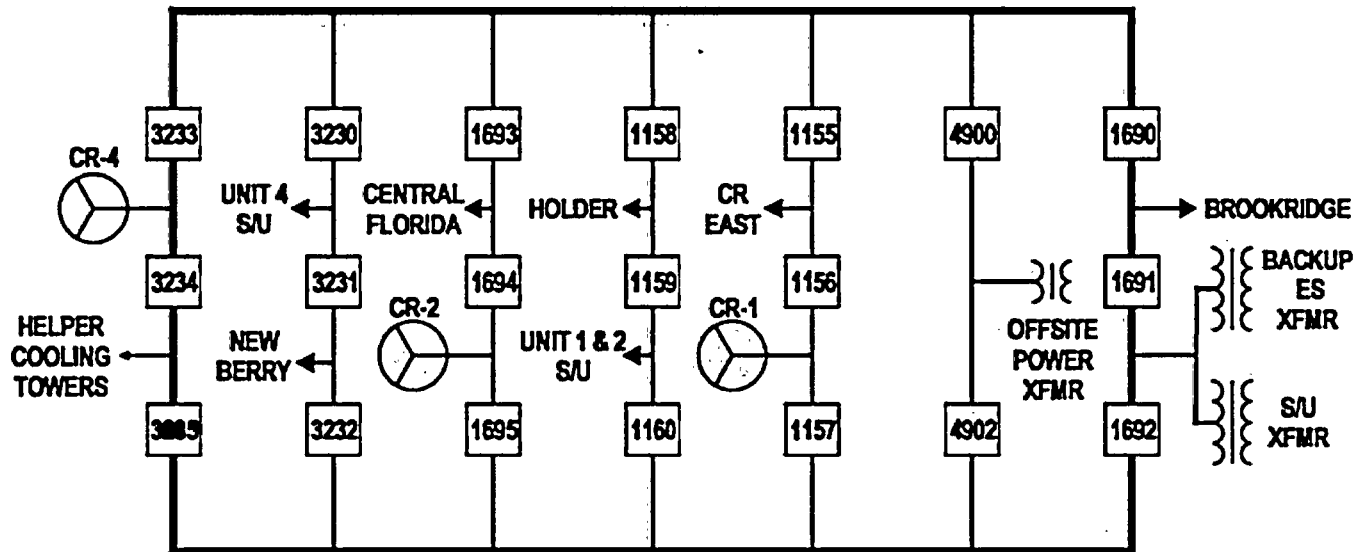
FIGURE 1

At 11:02 on September 6, 2004, a fault on the 230 kilovolt (kV) Brookridge transmission line [FK, CBL] resulted in the opening of Breakers 1690 and 1691 (see Figure 1) [FK, BKR]. Mechanical failure of an insulator string [FK, INS] resulted in a phase-to-ground fault when the transmission line dropped into the metal transmission tower [FK, TWR]. That transmission tower is located along the transmission corridor approximately two miles from the CR-3 switchyard. This removed one of the sources of power to the BEST and Startup transformer [EB, XFMR].

At 11:51, on September 6, 2004, a fault on the 230 kV switchyard south bus [FK, BU] resulted in the opening of Breaker 1692 (see Figure 1). A phase-to-ground fault on Breaker 3232 resulted in actuation of the primary and backup bus differential relaying schemes [FK, 87] resulting in the tripping of Breakers 3235, 3232, 3231, 1695, 1160, 1157, 4902 and 1692. This removed the remaining source of power to the BEST and Startup transformer. Improved Technical Specification (ITS) 3.8.1, Condition A, was entered for loss of the BEST.

The cause for loss of the 230 kV Brookridge transmission line was mechanical failure of a vertical string of insulators on the "A" phase due to diameter loss and consequent failure of one of the carbon steel pins connecting the insulators to one another. The porcelain "ball and socket" insulators were stamped "LAPP 20000 1968," indicating that they were manufactured by the Lapp Insulator Company and were 1968 vintage. The diameter loss was caused by possible leakage current which led to spark erosion and severe electrochemical corrosion of the carbon steel pin. Corrosion/erosion reduced the cross section of the carbon steel pin sufficiently to result in tensile overload. The passing of Tropical Storm Frances resulted in tropical storm force winds that placed additional stress on the carbon steel pin. A phase-to-ground fault occurred when the "A" phase transmission line dropped and came in contact with the metal transmission tower.

The tripping of the 230 kV switchyard south bus was due to a flashover ("B" phase-to-ground) on breaker 3232 due to contamination from wind and salt spray from the passing of Tropical Storm Frances. The bus differential relaying schemes functioned as designed based on the fault condition of the breaker and isolated the fault by opening breakers 3235, 3232, 3231, 1695, 1160, 1157, 4902 and 1692. Since the relaying functioned as designed to protect the adjacent equipment from the fault and the fault occurred as a result of Tropical Storm Frances, there were no inappropriate acts or equipment failures. Therefore, there is no corrective action to prevent recurrence of this condition.

1. CR-3 Administrative Instruction AI-704, "Reactor Trip Review and Analysis," was performed.
2. The failed vertical string of insulators was replaced. Vertical and "V" string insulators on the 230 kV Brookridge transmission line towers located along the transmission corridor adjacent to the CR-3 access road were inspected. Thirteen additional vertical strings of insulators were subsequently replaced on the 230 kV Brookridge transmission line.
3. A 230 kV switchyard south bus reenergization plan was created and implemented. The primary purpose of this plan was to reveal internal breaker faults prior to bus restoration. No internal breaker faults were identified. The 230 kV switchyard south bus breakers were closed and the 230 kV switchyard south bus was restored on September 7, 2004.

4. Breaker 3232 was evaluated. Physical evidence was found to confirm that a flashover had occurred from the "B" phase to ground. A series of tests were performed on the breaker with results being acceptable. In addition, an internal inspection was performed on the "B" phase of the breaker with results being acceptable. A complete hot wash was performed on insulators and breakers on the 230 kV switchyard south bus prior to CR-3 restart. A visual inspection of other sections of the 230 kV switchyard buses was also performed. The determination was made that additional hot washing was not required.
5. Other actions associated with this event are being addressed in the CR-3 Corrective Action Program in Nuclear Condition Report 136752.
